## **Charge Control C Errata**

chargebyte GmbH

Oct 26, 2023

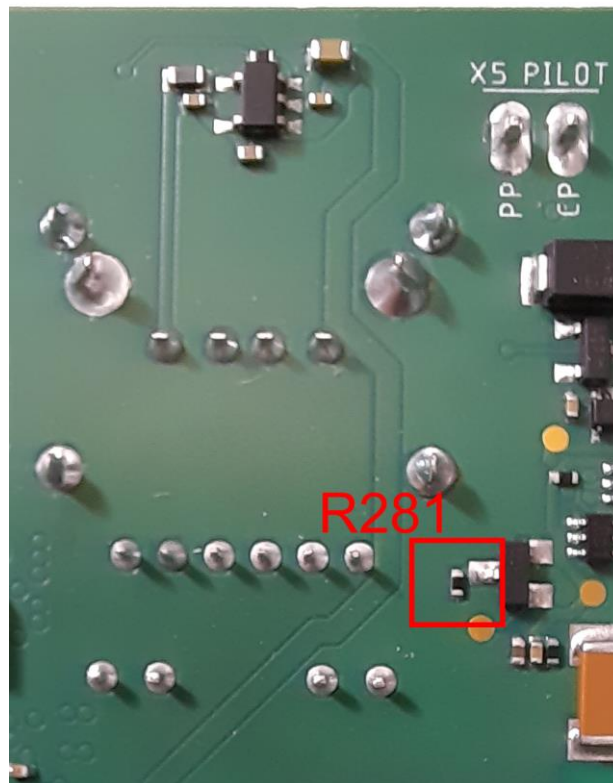
Figure 1 Placement of R281

It was found that a logic gate might suffer from an open input due to a missing resistor on its input. Open inputs on logic gates are forbidden by common design rules, since the behaviour of logic gates is general unpredictable/not defined for such cases.

This missing resistor (R281) is part of the Control Pilot control circuit. It is placed on the bottom side of the PCB, see following photo (where R281 is already populated).

Therefore, the Control Pilot interface, particularly the generation of the pulse-width modulation (PWM), might misbehave or does not function at all.

In worst case, this PWM does not function at all due to this missing resistor.

An attached Electric Vehicle is not able to detect the charging station without working PWM, thus in worst case, no charging is possible.

While internal end-of-line manufacturing tests proved that all shipped boards currently work as expected, corner cases might rise due to ageing of parts which then lead to unpredictable and/or erratic behaviour of Control Pilot interface, even final dysfunctionality might occur.

No workaround exists, only fixing is possible by populating the missing resistor.

Affected products (see chart above) which are shipped after July 1st, 2021 are reworked to include the missing resistor.

Additionally, new product versions (V0R5e and following) are created and released to customers which include the missing part by design.
