I2PLCTR Errata

chargebyte GmbH

2024-01-08

2 Transformer Failures

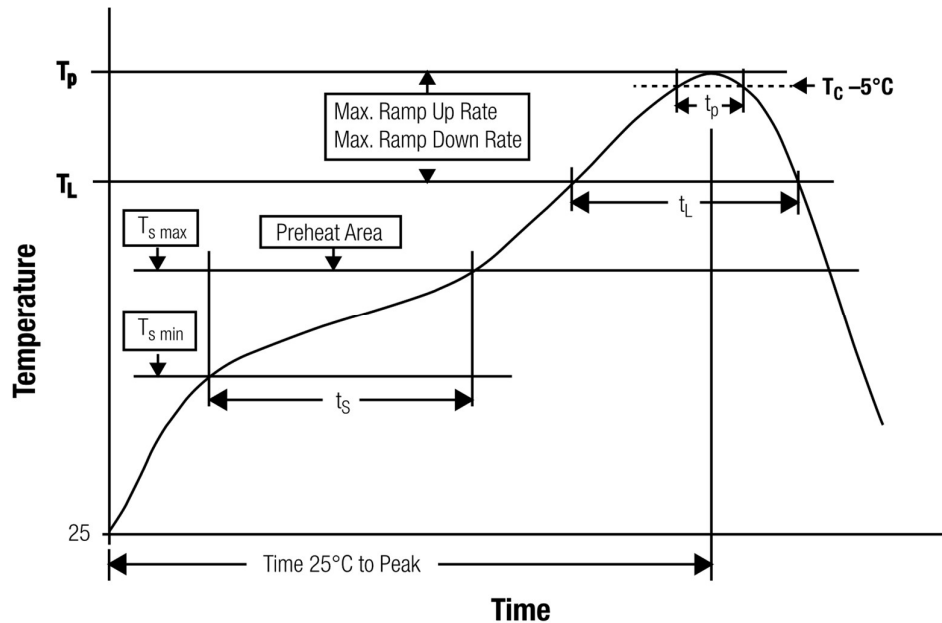
Figure 2 Reflow Profile

Please make an effort to minimize the temperature rise before ramp-up, while ensuring adherence to standard specifications. Through our comprehensive investigations and testing, we have identified a modification in the delta T over time for both soak time (t_s) and time to peak as depicted in the figure below, reduces the failure rates to an absolute minimum. Put more simply. Try to extend the time to peak temperature T_p as long as possible to ensure slow heating and avoid sudden expansion of water.

This setting has considerable potential for improving drying quality and avoiding problems caused by the rapid expansion of moisture in the components. If you allow sufficient time during the preheating phase, the moisture in the parts should dissipate completely. We recommend that you integrate these improvements into your processes.
